# Silica Induced Tribological Degradation in an Industrial Pelletizer Bearing: A Multiscale Failure Analysis

The objective of this work is to determine the failure mechanism of an NU240 cylindrical roller bearing installed on the main shaft of an industrial pelletizer through a multiscale characterization of the bearing components, lubricant, and degradation products generated during service. Whereas previous investigations of SiO<sub>2</sub>-contaminated lubricated systems, such as those of Ikhsan et al. [6] and Ta et al. [7], have relied on controlled laboratory conditions to evaluate individual wear mechanisms separately, this work addresses a real in-service failure and proposes an integrated methodology capable of reconstructing the complete degradation sequence, from silica contamination to functional blockage of the bearing, directly from field evidence. The results demonstrate that external silica particles initiate lubricant film breakdown, promote the transition from abrasion-dominated wear to combined abrasion, adhesion, and tribocorrosion, and ultimately lead to functional blockage of the bearing. The proposed methodology contributes to predictive

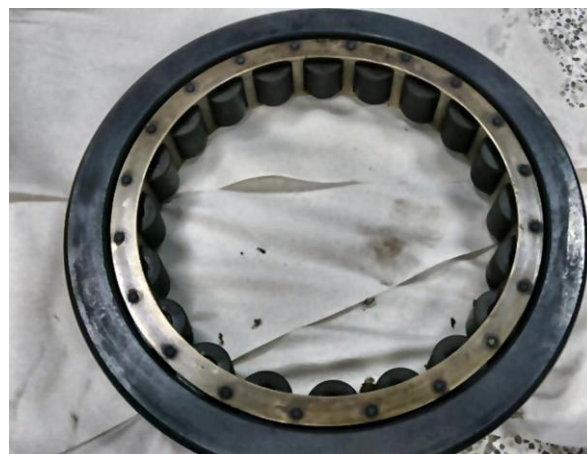
Initial inspection of the NU240 bearing, carried out after progressive braking was detected throughout its rotation, revealed lubricant of abnormally high density and brown corrosion products deposited on the outer and intermediate surfaces of the component. After cleaning the parts following the procedure of ASTM G1-03(2017)e1 described in Section 2.3 [11] (Figure 1), the bearing showed severe deterioration of the contact surfaces, together with a substantial loss of the rolling elements' rotational capability. The inner and outer raceways exhibited dark-colored regions, adhered deposits, and areas of localized wear,

while the cylindrical rollers showed surface deformation and accumulation of solid particles.

**Fig. 1.** NU240 bearing after cleaning following the ASTM procedure.

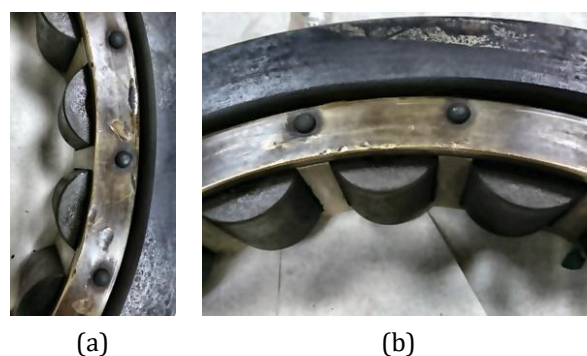
These observations indicate that the system underwent progressive degradation during operation, ruling out an instantaneous failure event and suggesting a cumulative mechanism associated with unfavorable tribological conditions. Fractographic analysis of one region of the bearing (Figure 2) further revealed anomalous plastic deformation for this type of component, possibly related to the assembly of the unit on the pelletizer shaft [12].

**Fig. 2.** Regions of the bearing showing anomalous plastic deformation, possibly associated with assembly of the unit.

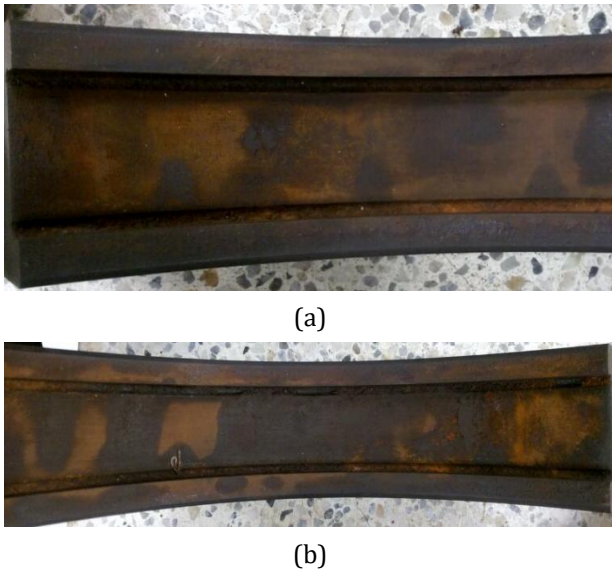
During disassembly, a considerable amount of solid debris mixed with the lubricant was identified, together with compacted deposits on the cage and raceways. Once the steel raceways and cylindrical rollers were separated (Figure 3), highly deteriorated zones were observed with galvanic-type corrosion products, generated by the ionic exchange characteristic of prolonged immersion in the lubricant between anodic and cathodic regions of the metal surface [13].

**Fig. 3.** (a) General view of the bearing's metal raceway, showing galvanic corrosion and surface deterioration, (b) Detail of the metal raceway showing anodic and cathodic zones associated with galvanic corrosion.

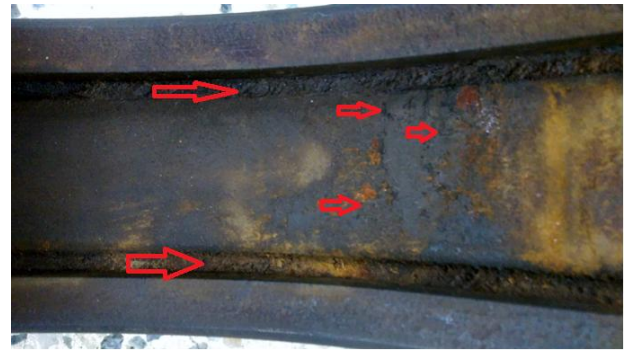
Optical microscopy identified different deterioration mechanisms distributed over the raceways and rolling elements. In the region shown in Figure 4, abrasive wear is observed on the steel raceway, with particle accumulation and appreciable material removal in the outer grooved areas, as well as particle embedding in the central region. This pattern is consistent with the ingress of external contaminant particles into the lubrication system. At the edges of the same region, particles detached from the bearing itself are observed, attributable to cavitation, most likely caused by the absence of an adequate filtration system in the lubrication circuit.

**Fig. 4.** Raceway region showing abrasive wear, particle accumulation, and material detachment.

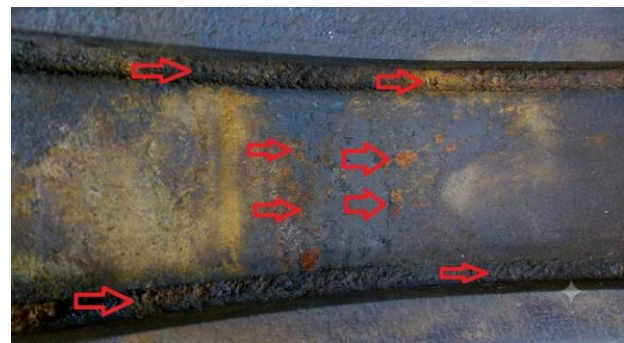
In an adjacent region of the raceway (Figure 5), cavitation wear was identified, characterized by material detachment associated with the intermittent implosion of bubbles generated by abrupt pressure changes in the oil, preferentially located along the direction of maximum applied load. Metallographic magnification of this area (Figure 6) revealed regions of extensive surface destruction, with cavity formation attributable to excessive vibration, oil contamination with abrasive particles capable of promoting foam formation, and inadequate clearance between the shaft and the bearing [15]; the striations observed in the central part of these images correspond to superimposed abrasive wear.

**Fig. 5.** Raceway region showing cavitation wear in the direction of maximum load.

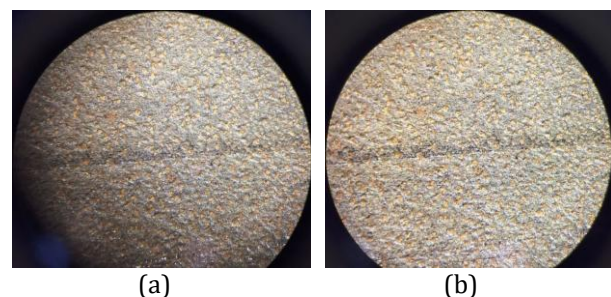
**Fig. 6.** Metallographic detail (40×) of the cavitation zones, with superimposed abrasive-wear striations.

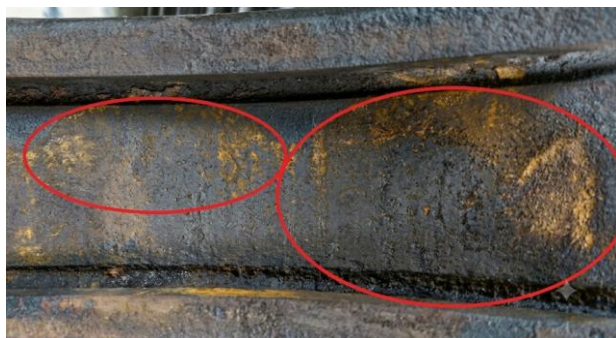
In another region of the steel raceway (Figure 7), adhesive wear was identified, generated by direct contact between the bearing and the

roller following total loss of the lubricant film. This mechanism can be associated with cold starts with low oil flow due to high viscosity, obstructions or leaks in the lubrication circuit, or misalignments that promote rubbing between the shaft and the bearing.

**Fig. 7.** Adhesive wear present on the steel raceway, resulting from direct contact between metal surfaces.

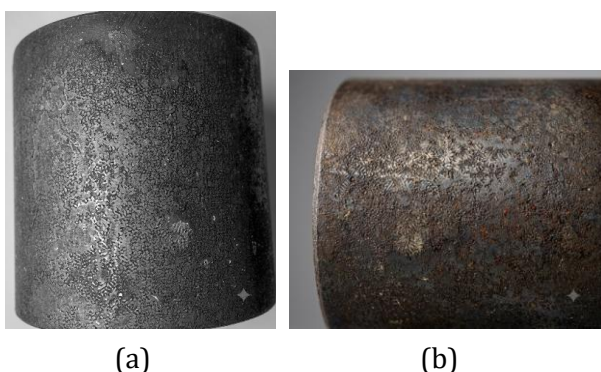
Fractographic analysis of the cylindrical rollers removed from the bearing (Figure 8) showed a deterioration pattern similar to that identified on the contacting steel raceways, dominated by abrasive wear. The corresponding micrographs (Figure 9) confirmed extensive areas where abrasive wear removed a considerable fraction of the metal surface; at 40× (Figure 9a), adhered metallic material is observed on the surface, while at 68× (Figure 9b), bronze-type material transferred from the cage to the roller is identified, evidencing that abrasive wear simultaneously affected the three components making up the bearing [16].

**Fig. 8.** Cylindrical rollers removed from the bearing, showing deterioration consistent with that observed on the steel raceways.

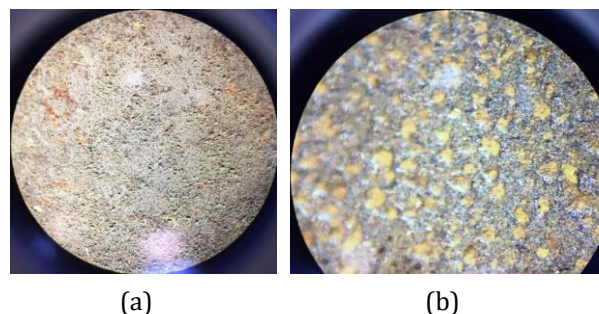
**Fig. 9.** Micrographs of the roller surface: (a) 40×, adhered metallic material; (b) 68×, transfer of bronze-type material onto the roller.

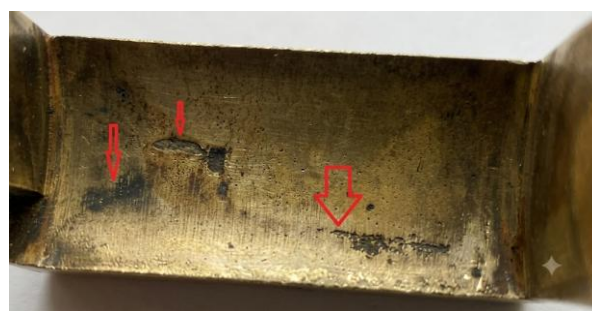
Finally, analysis of the bronze cage (Figure 10) revealed advanced adhesive wear, with transfer of metallic material from the steel roller, a direct

**Fig. 10.** Wear present on the bronze cage, resulting from contact between metal parts and deficient lubrication.

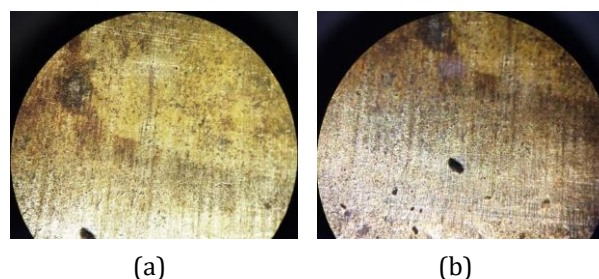
consequence of insufficient lubrication between the parts [17]. Micrographs of two different regions of the cage (Figure 11) confirm zones of severe adhesive wear and appreciable metallic mass loss, evidencing that the degradation phenomenon affected the three main bearing components in a generalized manner.

**Fig. 11.** Cage regions in direct contact with the rollers, showing accelerated wear due to part deformation.

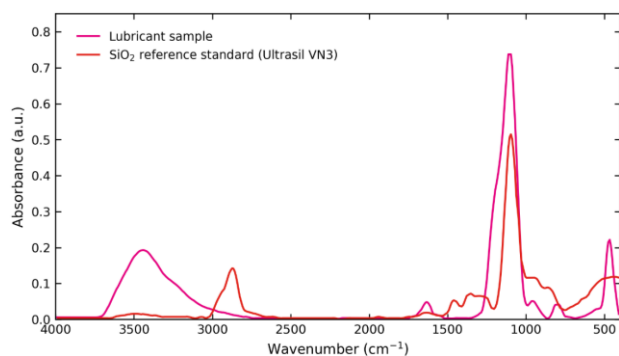
The FTIR spectra obtained for the lubricant samples (Figures 12 and 13) showed, in addition to the characteristic bands of the organic oil matrix, signals corresponding to inorganic substances foreign to the original

composition of the lubricant [18]. It should be noted that FTIR is primarily a qualitative technique: it does not allow direct quantification of the concentration of the identified contaminant, since the obtained signal depends on multiple factors, including particle size, distribution within the matrix, and spectral overlap with the organic bands of the oil; nonetheless, it enables the unambiguous molecular identification of the species present through their characteristic vibrational bands. In both spectra, the signals matched the  $\text{SiO}_2$  reference patterns closely and consistently between the two samples analyzed, confirming the ingress of silica particles (sand or quartz) into the lubrication system.

**Fig. 12.** FTIR spectrum of oil sample 1, showing the presence of  $\text{SiO}_2$  particles.

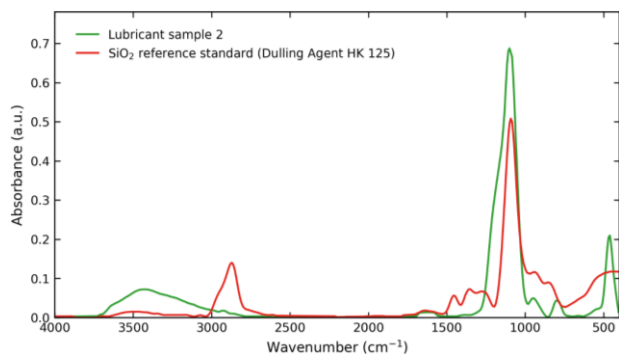
**Fig. 13.** FTIR spectrum of oil sample 2, confirming the presence of  $\text{SiO}_2$  together with the other lubricant constituents.

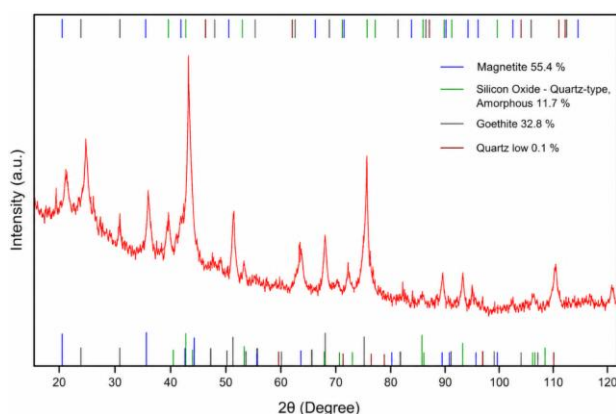
The diffractogram obtained for the metal surface of the radial bearing (Figure 14) identified magnetite and goethite as the main corrosion products, together accounting for 88.2%, along with a  $\text{SiO}_2$  fraction close to 12%. This result is consistent with the severe wear observed on the metal parts and confirms the simultaneous presence of oxidation phenomena and mineral contamination.

**Fig. 14.** Diffractogram of the metal surface of the NU240 radial bearing.

| Sampling point | Iron oxides (magnetite + goethite) [%] | $\text{SiO}_2$ [%] |
|---|---|---|
| Metal surface of the NU240 radial bearing (Fig. 14) | 88.2 | 12.0 |

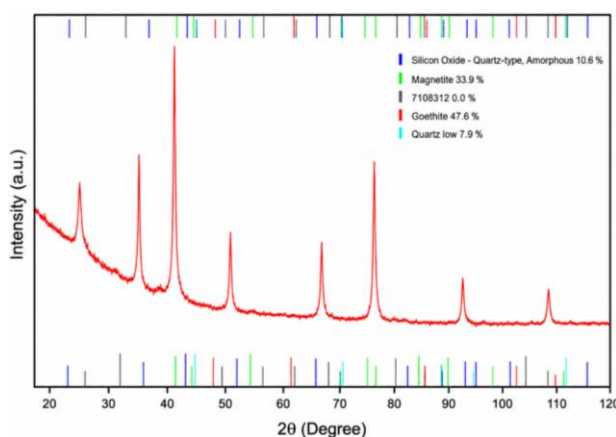
Analysis of the solid debris collected between the bearing parts (Figure 15), with an appearance corresponding to solidified lubricant, likewise showed corrosion products (magnetite and goethite) totaling 82%, together with 18%  $\text{SiO}_2$  [19]. Based on this evidence, it was established that the contaminant responsible for the wear of the parts is of external origin, resides within the lubricant, and, due to the continuous movement of the components, tends to deposit on previously worn metal areas.

**Fig. 15.** Diffractogram of the solid debris recovered from the lubricant, showing corrosion products and  $\text{SiO}_2$ .

| Sampling point | Iron oxides (magnetite + goethite) [%] | $\text{SiO}_2$ [%] |
|---|---|---|
| Solid debris from the lubricant, radial bearing (Fig. 15) | 82.0 | 18.0 |

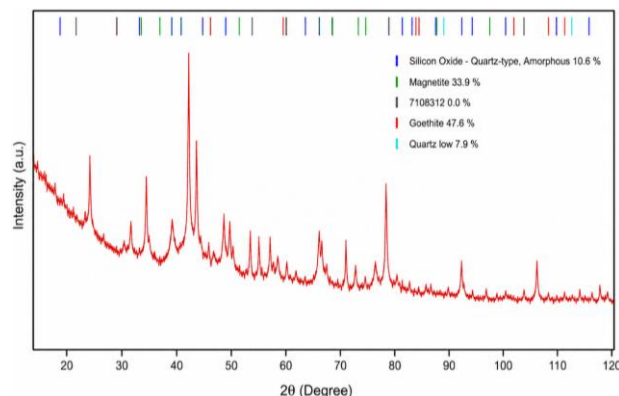
As a complementary sample, the roller surface of the 89456M axial bearing (Figure 16), which had been exposed to the environment, was also analyzed. In this case, magnetite was identified as the sole corrosion product, at a high proportion (71%) associated with sediments formed in an aqueous medium [20], together with a  $\text{SiO}_2$  fraction of 29%. This result confirms that both the parts removed from the axial bearing and those from the radial bearing show an appreciable content of contaminant particles, and suggests that the higher relative proportion of silica in the axial roller may be related to its greater density relative to the lubricant, which favors its progressive sedimentation compared with particles suspended in the circulating oil.

**Fig. 16.** Composition spectrum of the contaminants identified on the roller of the 89456M axial bearing.
