A Description of the Wear Damage of Backhoe Bucket Teeth

ABSTRACT

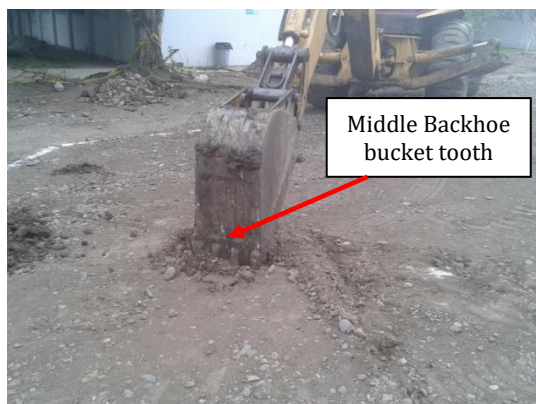
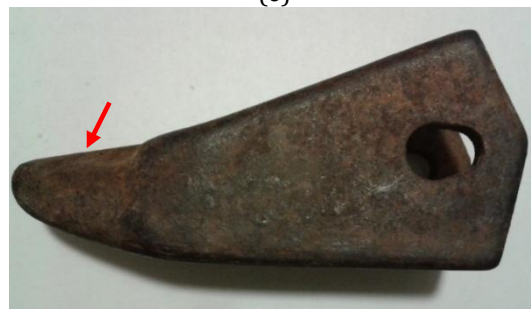
Fig. 1. (a-c) Backhoe bucket tooth in real service, Wear damage: (c) Tooth top section, (d) Tooth bottom section (e)-(f) Left-right sides.

The wear profiles were very consistent at the top and bottom sections of the tooth. The profiles correlate well with the wear damage observed on the tooth surfaces in Figure 1b-e. In this particular case, the profiles showed a certain degree of uniformity across the measured distance; however, at some points there are deeper areas characterized by changes in the profile. These areas correspond to the pitting actions, the measured depth oscillating between 0.04 to 0.07 mm. The average roughness in both examined zones was $R_a = 304.16 \mu\text{m}$, with a standard deviation of 78.16. Ten profiles of each area, both the upper and lower parts of the tooth, were taken, and two profiles were selected to be shown in this work.

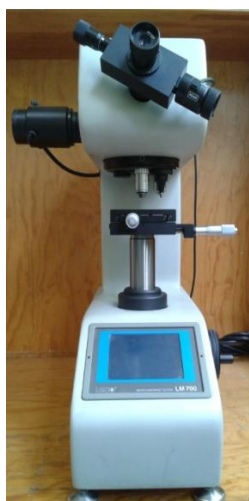
Hardness tests were carried out using a durometer (Microhardness Tester LECO LM 700) (see Figure 3). Ten microhardness values were acquired in the cross-section of one segment of the worn tooth (see Figure 2) and an average value was obtained, in accordance to ASTM E384-17 [9]. The average microhardness was $540.61 \text{ HV} \pm 1.07$, the applied load to the Vicker's indenter (square-based diamond pyramid) was 1000 gf, whereas the dwell time was 15 s; this result was similar to one of the tested materials in another research works [4].

Fig. 3. Microhardness data obtained by using Microhardness Tester LECO LM 700.

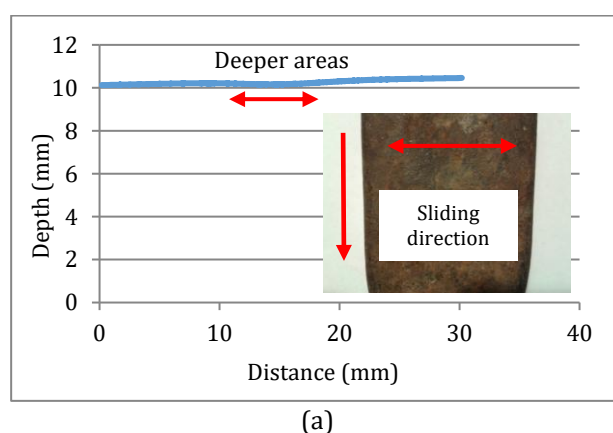
To carry out the profile and roughness analysis in different areas of the bucket tooth, it was necessary to use a Contour Measuring Instrument CV-500 (profilometer). Figure 4a-b illustrates the depth of the holes on the surface of the excavator tooth. In this case, the distance that the needle traveled over the surfaces was between 25 to 30 mm. The analyzed areas are indicated in the photographs.

Fig. 4. Surface profiles, (a) Top section, (b) Bottom section.

The hardness testing in this work, showed that the obtained values are quite common in alloy steels used commonly to manufacture bucket teeth for bearing heavy-duty processes. A tooth surface roughness analysis was conducted and the average roughness in the top and bottom areas of the tooth was $R_a = 304.16 \mu\text{m}$, with a standard deviation of 78.16. The depth profiles were obtained in a perpendicular direction of the impact orientation and the profiles were quite consistent, however, some areas had cavities that were deeper. The wear mechanisms identified in this particular work using optical microscopy, were severe abrasive wear, irregular scratches or indentations, corrosion, and pits on the surfaces.
