# Exploratory Study on the Wear Behavior of AISI 4140 Steel under Starved Lubrication and Laser Surface Texturing Conditions

Wear in steel-to-steel contact systems represents a critical challenge under limited lubrication conditions. This study presents an exploratory investigation of the wear behavior of AISI 4140 steel in contact with D2 steel under starved lubrication and laser surface texturing conditions. A block-on-ring configuration was used to simulate sliding contact. A commercial water-based cutting fluid with emulsified characteristics was applied under starved conditions. Unlike conventional approaches favoring smaller texture diameters and high texture densities to promote uniform lubricant distribution, in this study a laser surface texturing was implemented using larger circular pattern designed to enhance lubricant retention under starved lubrication regime. The results show a consistent trend toward reduced wear and improved friction stability when starved lubrication and the proposed surface texturing are combined allowing to reduce wear (mass lost) by 90% and significantly reducing the coefficient of friction by 73% compared to the maximum value observed in dry

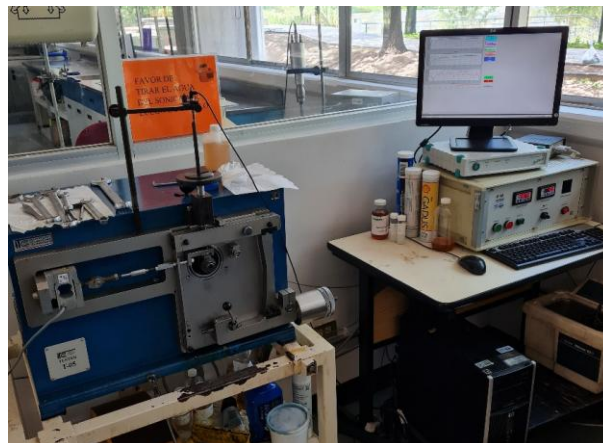
The tests were executed using a T05 Block-on-Ring Wear Tester manufactured by the Institute for Sustainable Technologies National Research Institute RADOM shown in Fig. 1.

**Fig. 1.** T05 Block-on-Ring Wear Tester machine used for the testing.

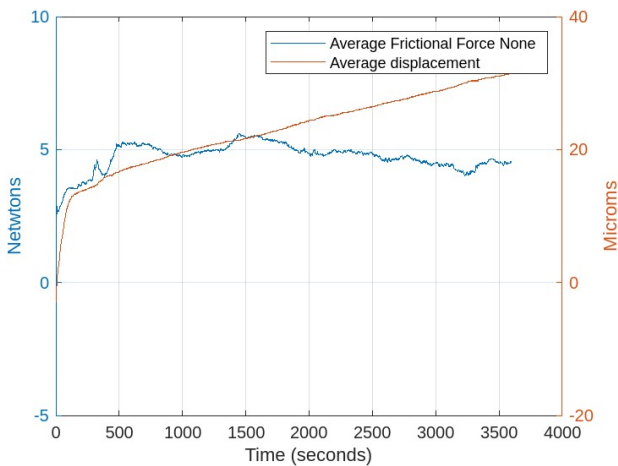
Combination 1 involved executing the test without any lubrication nor LST. As it is shown in Fig. 4 the average displacement increased up to 31.4375  $\mu\text{m}$  at the end of the test. The frictional force reached a maximum value of 5.61 N and showed a stabilized decreasing tendency below this value.

**Fig. 4.** Average frictional force and displacement versus time for combination 1.

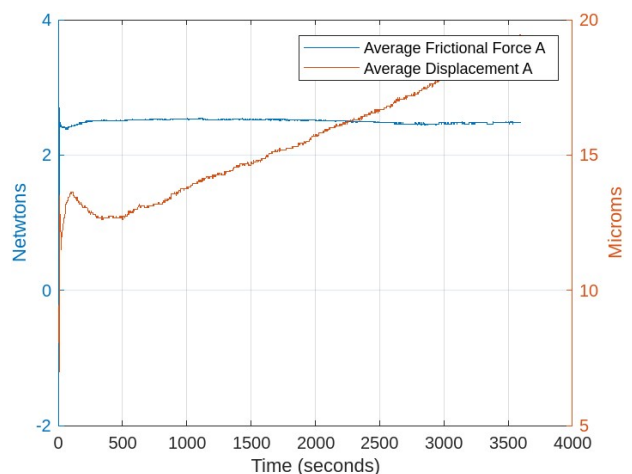
The average displacement increased slowly up to 19.4  $\mu\text{m}$ . The friction force showed a stable behavior, although higher values were observed compared to the dry condition as shown in Fig. 7.

**Fig. 7.** Average frictional force and displacement versus time for combination A.

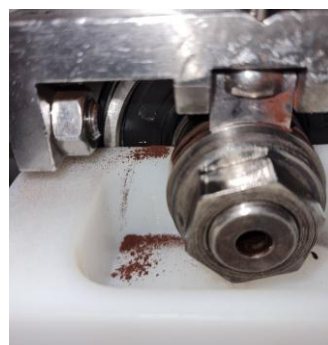
An important observation is that after the B tests, it was observed debris on the empty lubricant holder as shown in Fig. 11.

**Fig. 11.** Debris after testing samples from combination B.

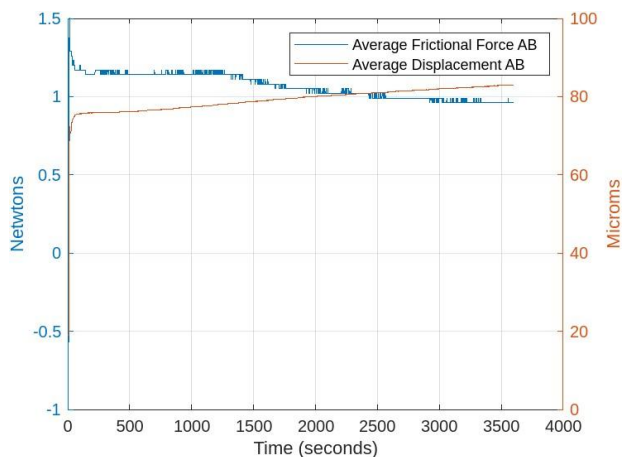
Combination AB involved lubrication and LST. The maximum average displacement was 83 µm. For this combination, it was observed a decreasing behaviour in the frictional force rather than incremental as it was in the case of combinations 1, A, and B as shown in Fig. 12.

**Fig. 12.** Average frictional force and displacement versus time for combination AB.

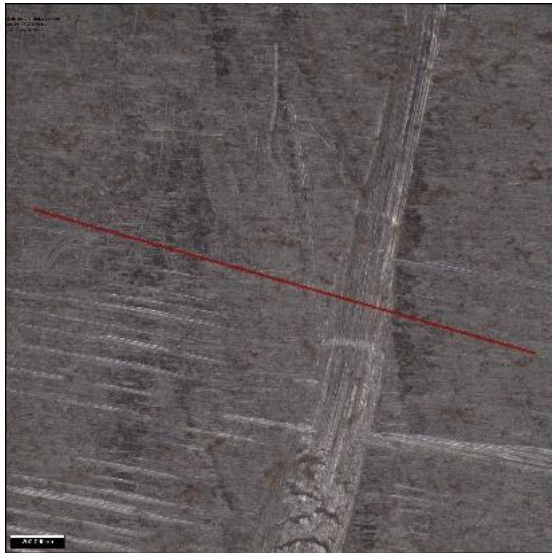
**Fig. 17.** Surface zone of combination A used to evaluate profile and roughness.

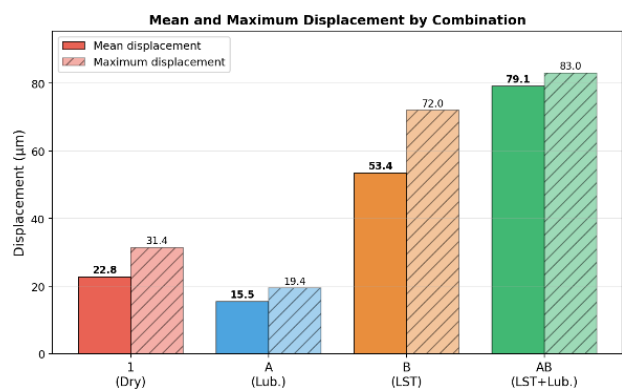
The average and maximum displacement values recorded by the T05 sensor for each combination are presented in Fig. 25. The displacement signal in the T05 system reflects the relative movement of the block holder as wear progresses, providing an indirect indicator of material removal and geometric conformity changes.

Combination A (starved lubrication) exhibited the lowest mean displacement (15.5 µm) and maximum displacement (19.4 µm), consistent with its lowest mass loss and the protective effect of the boundary lubricant film. Combination 1 (dry, no LST) showed intermediate displacement values (mean 22.8 µm, max 31.4 µm), reflecting progressive material removal throughout the test.

**Fig. 25.** Mean and maximum displacement by combination.

Combinations B and AB showed higher displacement values (max 72.0 and 83.0 µm respectively). For Combination B, the displacement increased progressively throughout the test duration, consistent with

continuous abrasive wear under dry conditions. In contrast, for Combination AB, analysis of the displacement time series revealed that approximately 54 μm of the total net displacement of 64 μm (measured as the change from initial to final sensor reading: 83 – 18.875 = 64.125 μm) occurred within the first 30 seconds of the test, after which displacement stabilized. This behaviour is attributed to rapid geometric conformity between the textured block surface and the D2 ring, rather than sustained material removal. The subsequent stable displacement rate of Combination AB was the lowest among all combinations, consistent with its superior tribological performance.

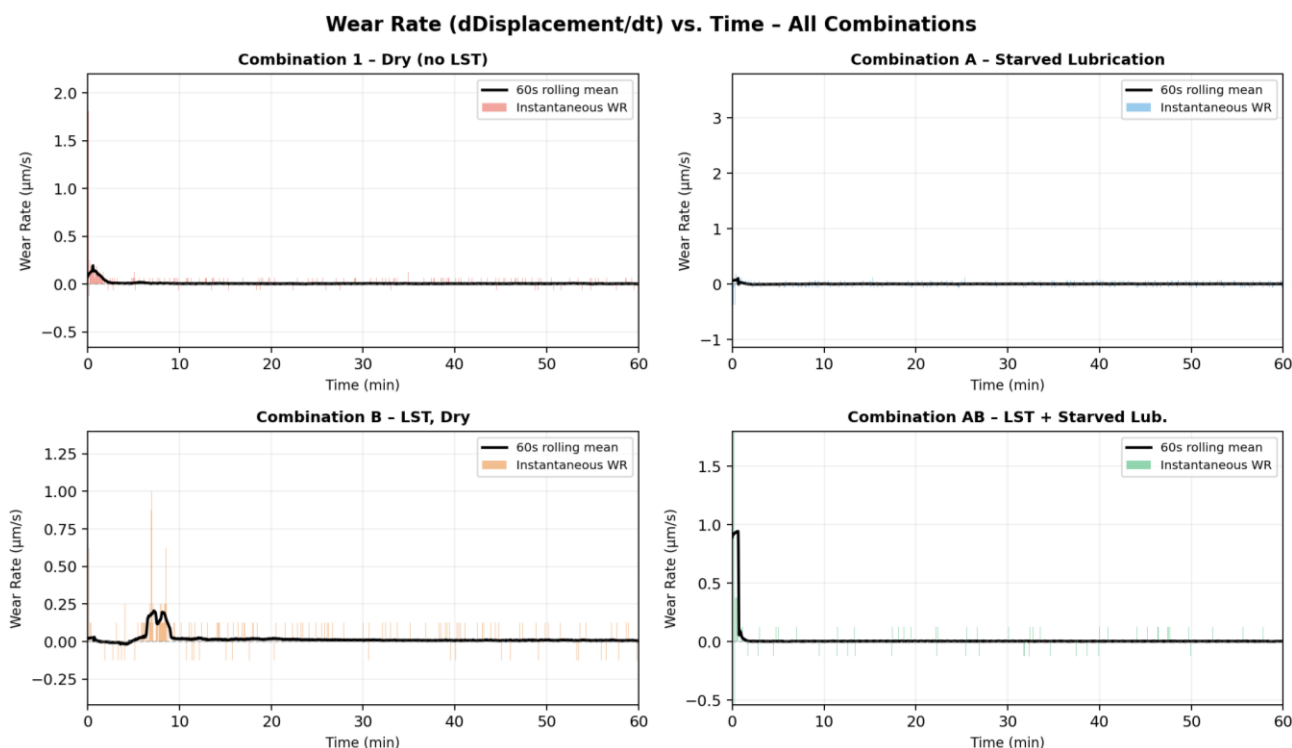
The wear rate was computed as the time derivative of the average displacement signal with respect to time (1), expressed in μm/s as shown in Fig.26. Positive values indicate active material removal events, while zero or negative values reflect sensor noise, elastic recovery, or stable contact phases. This variable provides insight into the dynamics of material removal throughout the test, complementing the cumulative mass loss and displacement measurements.

**Fig. 26.** Wear rate vs. time for all combinations. Bars represent instantaneous values; solid line represents the 60-second rolling mean.

As shown in Fig. 26, the wear rate behaviour differs substantially across combinations. Combination 1 (dry) exhibited a moderate initial wear rate that decayed progressively, reaching a stable level after approximately 10 minutes.

Combination B (LST, dry) exhibited sustained wear activity throughout the test, with a higher and more persistent rolling mean compared to the lubricated conditions.

Combination AB presented a distinct transient signature: a sharp wear rate peak of 15.5  $\mu\text{m/s}$  occurring between  $t = 8$  and  $t = 13$  s, corresponding to the rapid geometric conformity phase identified in the displacement analysis.

Following this initial phase, the wear rate dropped immediately to the lowest sustained level among all combinations, confirming that the apparent high displacement in AB is attributable to initial seating rather than progressive material removal as shown in Fig. 27.

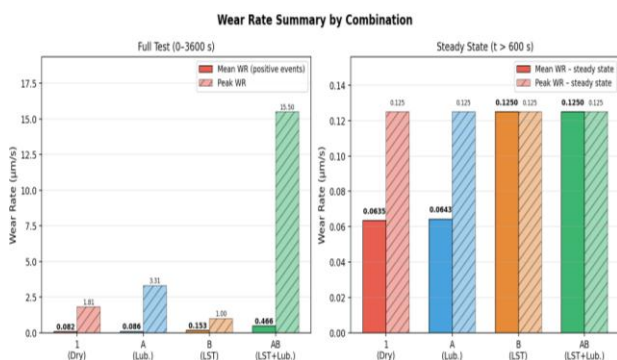
**Fig. 27.** Wear rate summary by combination: mean and peak values for the full test (left) and steady-state phase (right,  $t > 600$  s).

Fig. 27 presents the mean and peak wear rate values for each combination under full-test and steady-state conditions, computed over active wear events ( $\text{WR} > 0$ ). During the full test, the mean positive wear rate of Combination AB appears elevated (0.466  $\mu\text{m/s}$ ) due to the brief but intense initial seating event.

In contrast, the steady-state mean wear rate of AB (0.125  $\mu\text{m/s}$ ) is identical to that of Combination B, indicating that once geometric conformity is achieved, both textured conditions produce the same instantaneous wear rate magnitude during active events.

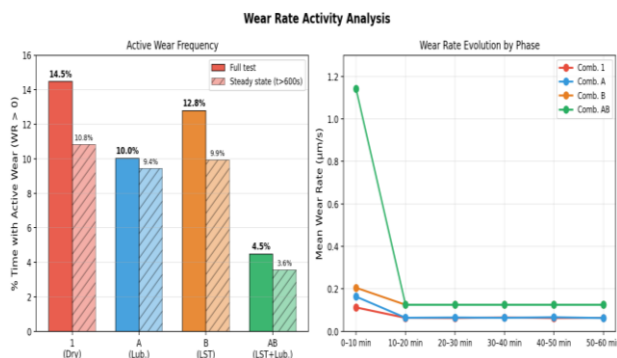
**Fig. 28.** Active wear frequency (left) and wear rate evolution by 10-minute phase (right).

Notably, Combinations 1 and A converge to nearly identical steady-state mean wear rates (0.0635 and 0.0643  $\mu\text{m/s}$  respectively), suggesting that the dominant factor distinguishing their total wear is not the magnitude of individual wear events but their frequency — as confirmed by the active wear frequency analysis as shown in Fig. 28.

Fig. 28 reveals that Combination AB exhibited active wear ( $\text{WR} > 0$ ) during only 4.5% of the total test duration (3.6% in steady state), compared to 14.5% for Combination 1, 10.0% for A, and 12.8% for B. This represents a reduction of approximately 67% in active wear time relative to the dry condition during steady state. The phase evolution plot (right) confirms that all combinations converge toward similar instantaneous wear rate levels after the first 10 minutes, and that the key differentiator of AB is the dramatically reduced frequency of wear events rather than a lower per-event magnitude.
