# Silica Induced Tribological Degradation in an Industrial Pelletizer Bearing: A Multiscale Failure Analysis

The objective of this work is to determine the failure mechanism of an NU240 cylindrical roller bearing installed on the main shaft of an industrial pelletizer through a multiscale characterization of the bearing components, lubricant, and degradation products generated during service. Whereas previous investigations of SiO<sub>2</sub>-contaminated lubricated systems, such as those of Ikhsan et al. [6] and Ta et al. [7], have relied on controlled laboratory conditions to evaluate individual wear mechanisms separately, this work addresses a real in-service failure and proposes an integrated methodology capable of reconstructing the complete degradation sequence, from silica contamination to functional blockage of the bearing, directly from field evidence. The results demonstrate that external silica particles initiate lubricant film breakdown, promote the transition from abrasion-dominated wear to combined abrasion, adhesion, and tribocorrosion, and ultimately lead to functional blockage of the bearing. The proposed methodology contributes to predictive

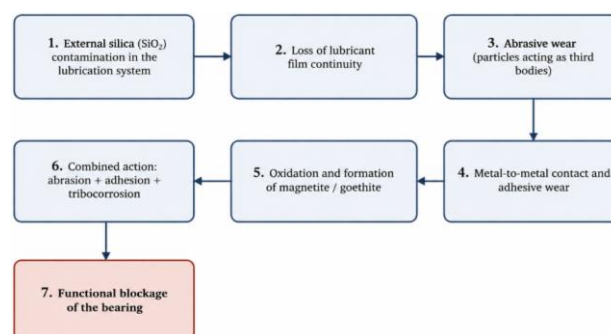
The integration of the evidence obtained from visual inspection, microscopy, FTIR, and XRD allowed a progressive bearing-degradation mechanism to be established, summarized schematically in Figure 17. Initially, the ingress of silica particles contaminated the lubricant and altered the tribological conditions of the contact; these particles acted as an abrasive third body, generating micro-cutting on the raceways and promoting increased surface roughness.

As abrasive wear progressed, the lubricant film lost continuity, allowing direct contact between the metal surfaces and promoting adhesive wear mechanisms. The continuous generation of metallic particles further increased lubricant contamination, while the rise in temperature and exposure of the base material favored the formation of magnetite and goethite as corrosion products. Finally, the combined action of abrasion, adhesion, and tribocorrosion produced a progressive increase in the

resistance to motion of the rolling elements, culminating in functional blockage of the bearing and loss of system operability.

**Fig. 17.** Schematic of the proposed failure mechanism for the NU240 bearing, from external silica contamination to functional blockage of the component.

systems with low sampling frequency or inadequate filtration [21]. Consequently, it is recommended that routine monitoring be complemented with techniques of greater structural specificity, such as FTIR or XRD, when operational symptoms of deterioration are not explained by conventional reports.
